# Geophysical Research Letters

Carvajal, M., Araya-Cornejo, C., Sepúlveda, I., Melnick, D., & Haase, J. S. (2019). Nearly instantaneous tsunamis following the Mw 7.5 2018 Palu earthquake. *Geophysical Research Letters*, 46. <https://doi.org/10.1029/2019GL082578>

## Nearly Instantaneous Tsunamis Following the Mw 7.5 2018 Palu Earthquake

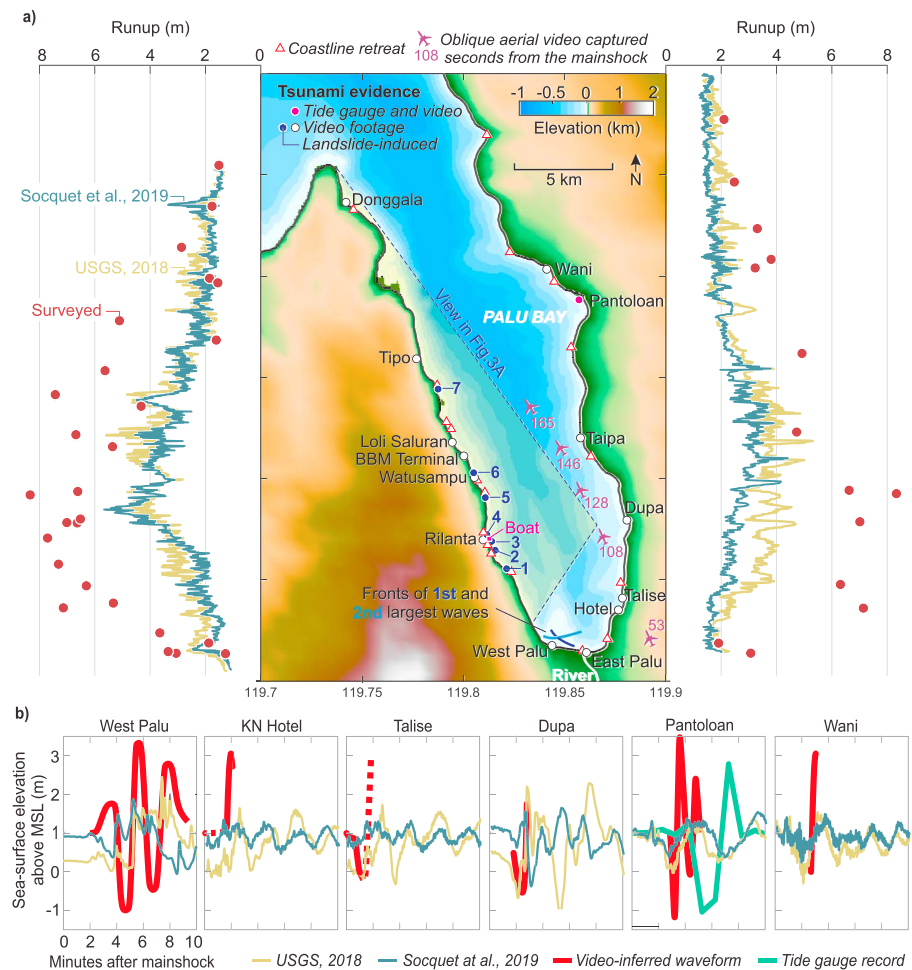
**Figure 2.** Observations and modeling results. (a) Map showing tsunami video location names (white and magenta circles), location of coastline retreat identified from satellite imagery (triangles), and flight path and timing (in seconds after the mainshock) of the aircraft pilot who recorded the point-source tsunamis shown in Figure 3a (video 38). The left and right panels show a comparison of tsunami runups measured by field surveys (Fritz et al., 2018) with those simulated based on existing coseismic slip models (Socquet et al., 2019; USGS, 2018). (b) Tsunami waveforms reconstructed from video footage (red) and predicted by the Socquet et al. (2019; blue) and USGS (2018; tan) coseismic slip models. The red dashed lines represent the waveform segments interpreted from videos with lower confidence (see text). Tsunami waveforms (available in Data Set S2) were inferred using videos 15–21 at Palu west (see video compilation 43), videos 1–3 at the KN Hotel (see video compilation 42), video 13 at Talise, video 14 at Dupa, video 11 at Pantoloan, and videos 7 and 8 at Wani (Table S2). Note the longer period waveform of the Pantoloan tide gauge record (green) with respect to the waveform reconstructed from closed circuit television footage (red). Tsunami simulations (runups in a and waveforms in b) and the video-inferred tsunami waveforms (b) are plotted as sea surface elevation including the high tide level of ~1 m above mean sea level at the time of the earthquake (Figure 1b).

In Figure 2b, the waveforms derived from video footage show the tsunami amplitude and timing at six locations (see Data Set S2 for waveform data). For reference we show the simulated tsunami waveforms predicted from the Socquet et al. (2019; blue) and USGS (2018; tan) earthquake rupture models. The tsunami occurred at high tide, corresponding to  $\sim 1$  m above mean sea level (MSL). The vertical coseismic seafloor deformation generated by the source model at each location added to the tidal value gives the initial sea surface elevation above MSL shown in the figure. For example, at Dupa, the Socquet et al. (2019) model, which concentrates slip beneath the center of the bay, predicts negligible vertical coseismic deformation and therefore the initial value is nearly the tidal level (i.e., 1 m above MSL). On the other hand, the USGS (2018) model predicts significant coseismic subsidence of the seafloor at Dupa; therefore, the water drops with the land instantaneously in our simulations, producing an initial sea level of approximately 0.5 m above MSL. See Text S1 for the details of the waveform reconstruction procedure.

Probably the most remarkable features of the tsunamis that devastated Palu were the very short, nearly instantaneous arrival times. Usually, it is assumed that the time lag between an earthquake and its associated tsunami spans from tens of minutes to several hours (Cienfuegos et al., 2018; Mori et al., 2011), depending on the distance to the source region. However, CCTV footage from the Kampung Nelayan Hotel (KN Hotel), on the southeast coast of Palu Bay, recorded devastating tsunamis arriving 100 s after the seismic shaking (videos 1–6 and compiled video 42, Text S2, and Figure S1). This extremely short arrival time is robustly estimated by the difference in the timing between seismic shaking and water inundation using three cameras that had a clear view of the coastline (videos 1–3). Another array of CCTV cameras at Wani, located 20 km north of KN Hotel, showed tsunami inundation 3.5 min after the seismic shaking, which include the time needed for the tsunami to reach the site located 150 m inland (videos 7 and 8, Text S3, and Figure S2). If we assume a typical 5-m/s inundation rate, a positive-polarity wave (water level rise) should have reached the coast of Wani about 3 min after the mainshock (Figure 2b). Such an inference is consistent with reports from crewmembers of a passenger ship that was stranded on the adjacent coast (Figure S2 and video 9), who unanimously reported that immediately after the earthquake the sea level retreated significantly and was followed 3–5 min later by a large wave (Associated Press, 2018; Chicago Tribune, 2018; Text S3). This sea level pattern is consistent with the vertical movements of a container ship berthed at the Pantoloan port, 2.5 km south of Wani. There, a CCTV camera recorded more than  $\sim 2$  m of water drawdown  $\sim 3$  min after the end of seismic shaking followed by a rapid sea level rise of at least  $\sim 4$  m (Figure 2b, video 11, Text S4, and Figure S3). In summary, videos collected at the KN Hotel, Wani, and Pantoloan ( $\sim 20$ -km maximum separation) indicate rapid widespread tsunami inundation following the earthquake and provide valuable reconstructions of tsunami sea level waveforms at these locations (Figure 2b).

Negative-polarity waves (water level drawdown) occurring immediately after the earthquake followed by tsunami inundation were observed at some sites but were not ubiquitous around the bay. For example, at Talise, an evident water retreat occurred almost instantaneously with seismic shaking (continuous red line in the Talise waveform of Figure 2b), which then appeared to be followed by a large wave that spurred people to run landward (dashed red line in the Talise waveform of Figure 2b; video 13). A very similar spatiotemporal behavior of sea level appeared to occur ~4 km north at Dupa, where a tsunami bore rapidly formed after an evident water drawdown (Figure 2b and video 14). However, negative-polarity leading waves followed by bore fronts, if existed, were not evident in the CCTV videos at the KN Hotel (see video 3), which is located 5 km south of Dupa and only 1 km from Talise. Instead, we infer an initial positive inundation from a rapid sea level increase of at least 2 m (Figure 2b and video 3).

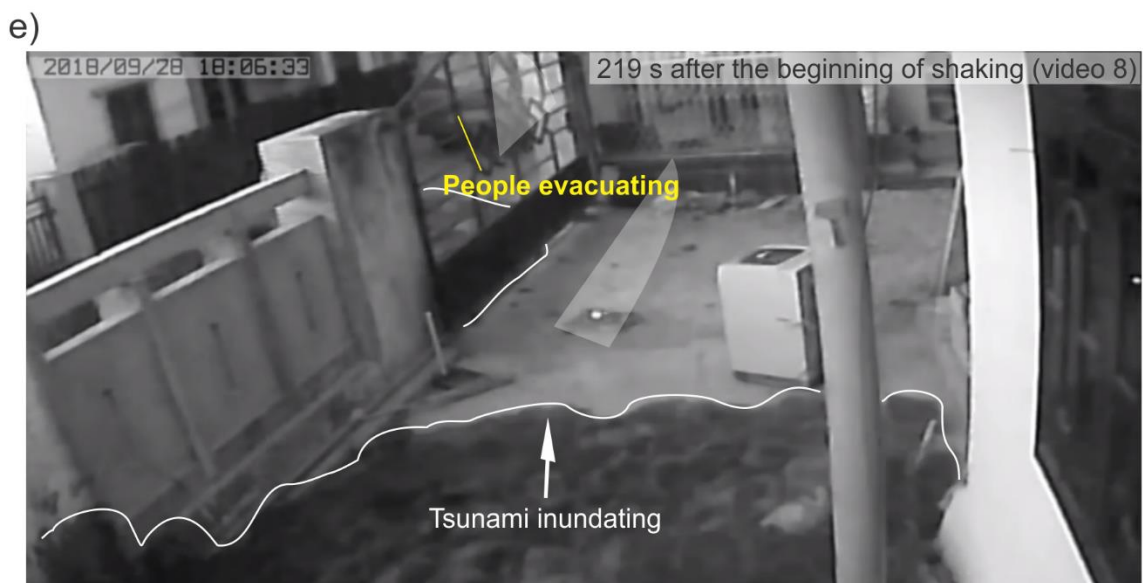
**Figure S2.** Video analyses at Wani. a) Map of Palu Bay and location of Wani. B) Aerial photo of Wani. Triangles indicate the location of the house (videos 7-8), stranded passenger ship (video 9) and moored fishing boat (video 10). c) Satellite image of Wani, showing the tsunami effect on the harbor (reported by crewmembers) and the inferred inundation area. d) Enlarged view of the study area, showing the local road configuration. The inset shows the house where CCTV videos 7-8 were taken, and the evacuation direction inferred from these. e) Snapshot of video 8 showing the direction of inundation relative to the evacuation road.

Two videos that rapidly caused widespread reaction on social media platforms were taken in a house at Wani, about 20 km north of the KN Hotel. After an exhaustive online search, we located the house on the map, which is shown in Figure S2. The house is 150 m landward from the coastline and about 20 m seaward from the local inundation limit that we inferred from satellite imagery (Fig. S5). The videos show (videos 7-8), from two different angles of CCTV cameras, children present in the front yard of the house when suddenly, at 18:02:54 (camera time), strong shaking begins. At 18:06:28, 214 seconds later, a tsunami inundates the front yard. Unlike the story at the KN Hotel, the timely exit of the children from the video scene, combined with the favorable orientation of the evacuation road very likely indicates a successful evacuation even for such a fast arriving tsunami (Fig. S2).

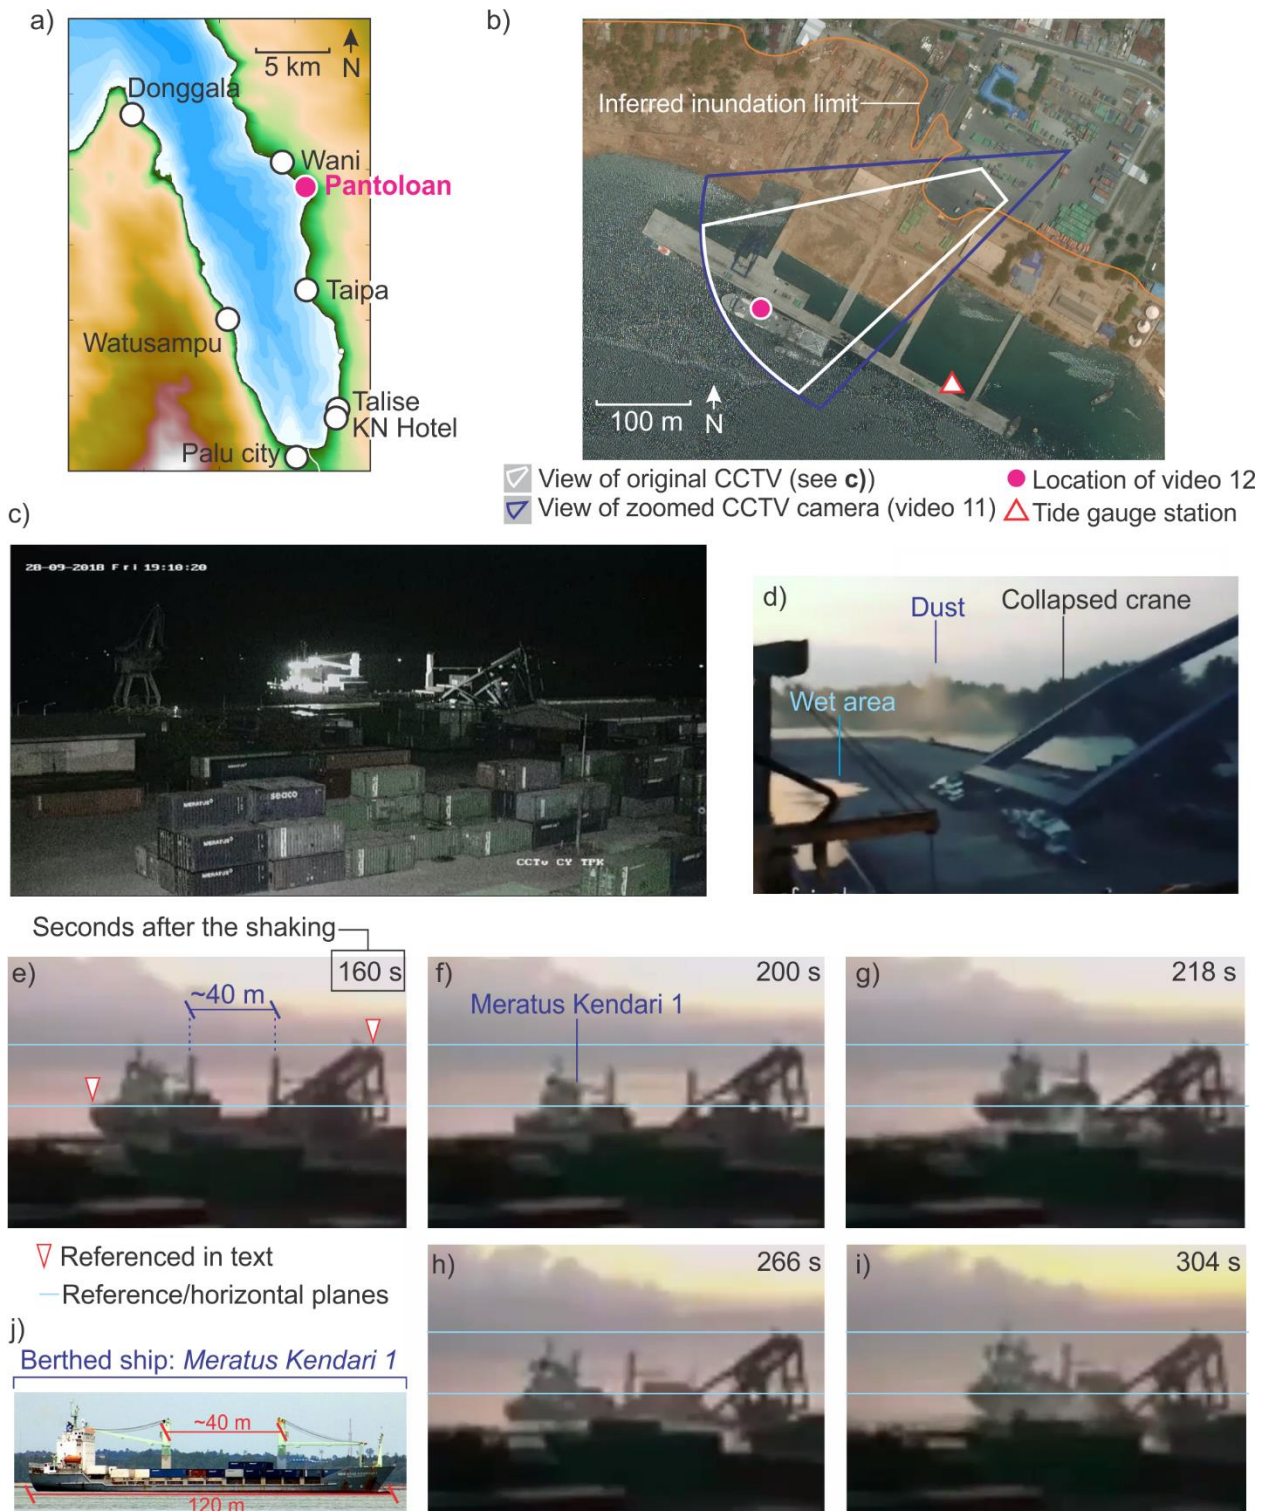
**Figure S3.** Video analyses at Pantoloan. a) Map of Palu Bay and location of Pantoloan. b) Satellite image of Pantoloan port, showing the inferred inundation area and the location and field of view of the CCTV camera (video 11) and video taken onboard the container ship (video 12). The location of the tide gauge station that recorded the tsunami (Fig. 1C) is shown by the red triangle. c) Snapshot from CCTV video 11 at a time

between the earthquake and tsunami. Note that the wharf has no signs of tsunami inundation and dust is likely coming from the collapse of a container crane. e-i) snapshots for video 11 from which the tsunami waveform was inferred. Tsunami amplitudes are inferred from actual dimensions of the KM Meratus Kendari 1, shown in j.

Tsunami waves observed at Pantoloan port by a CCTV camera challenge the only instrumental record inside Palu Bay. A CCTV video (video 11), unfortunately of poor resolution, recorded the shaking and subsequent tsunami waves (Fig. S3). The video also captures the moment when the container crane collapses due to the strong shaking (Figure S3). The sea-level behavior is inferred here by the vertical movements of the KM Meratus Kendari 1, a 120-m long container ship that was berthed at the north wharf when the earthquake and tsunami hit. A manual acceleration of the video is recommended to see more clearly the vertical movements of the ship. Using the ship’s dimensions as a reference (Fig. S3j), we infer an initial water retreat over 2 m beginning ~3 min after the end of seismic shaking followed by a rapid sea-level rise of at least ~4 m (Fig. S3e-i). The inferred tsunami waveform is shown in Figure 2B. Interestingly, the waveform at this initial time was not observed by the tide gauge station located at the same port (Fig. S3). Additional short video segments immediately after the earthquake, as well as after the initial tsunami waves caught by the CCTV camera, were captured by a crewmember onboard the ship (video 12). Although we could not retrieve additional information from this video, it supports the CCTV video observations, because it does not show an immediate water drawdown after the earthquake as inferred at other places, such as Wani, Dupa and Talise.

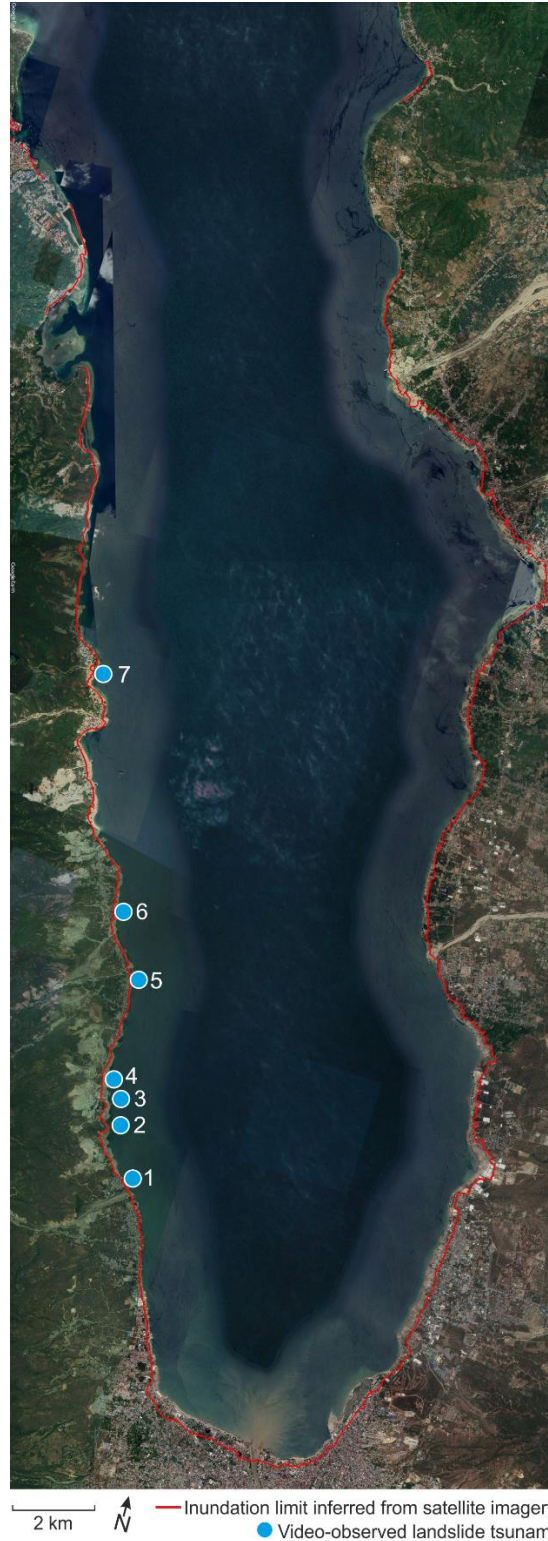
**Figure S5.** Inundation around Palu Bay inferred from detailed comparison of pre-and post-tsunami satellite images combined with amateur videos and photos. We inferred a maximum inland inundation of 420 m along the southeast coast of the bay.

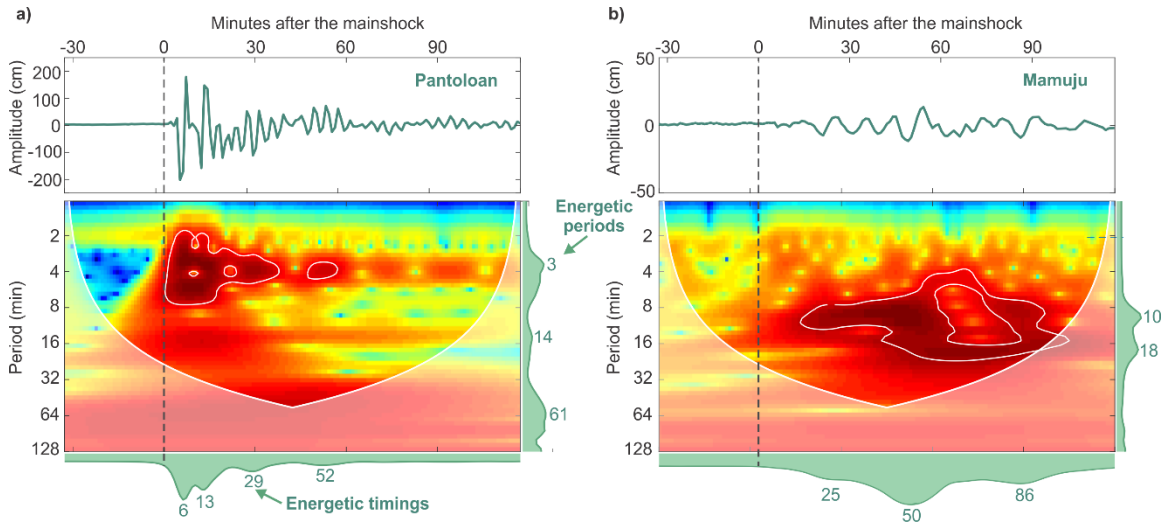
**Figure S6.** Time-frequency characteristics of the two tide gauge records available for the event: Pantoloan (a) and Mamuju (b) (Fig. 1C). Wavelet analysis was performed using the software package developed by Torrence and Compo (Torrence and Compo 1998), using a Morlet mother wavelet. Upper panels show the sea-surface elevation ( $\eta$ ) of the de-tided signals. The lower panels show the Wavelet Power Spectra (WPS), in which white contours indicate the 95% confidence level. The green shaded regions at the right and below the WPS show the time-averaged and scale-averaged wavelet spectra, respectively, where numbers indicate energetic periods (in minutes) and arrival times (in minutes), respectively. Times are relative to the mainshock occurrence.

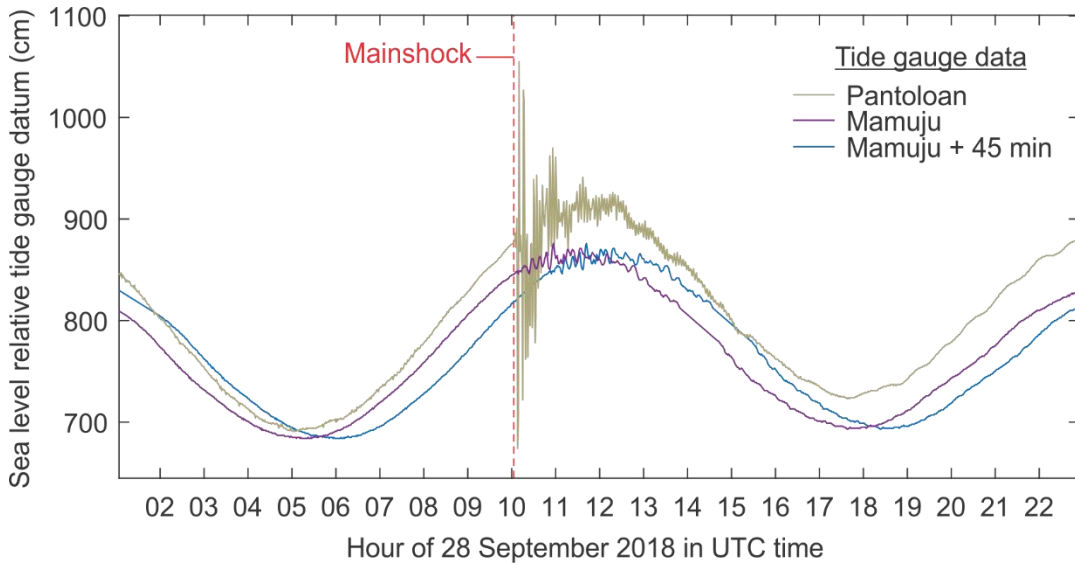
**Figure S7.** Comparison of the timing of the raw tide data recorded at Pantoloan (light brown) and Mamuju (purple). The blue curve is the Mamuju data delayed by 45 minutes as suggested by Heidarzadeh et al. (2018). Note that this time shift produces unrealistic differences in the tidal phases between Pantoloan and Mamuju which are 200 km apart. The time interval plotted corresponds to the day of the earthquake, 28 September 2018.

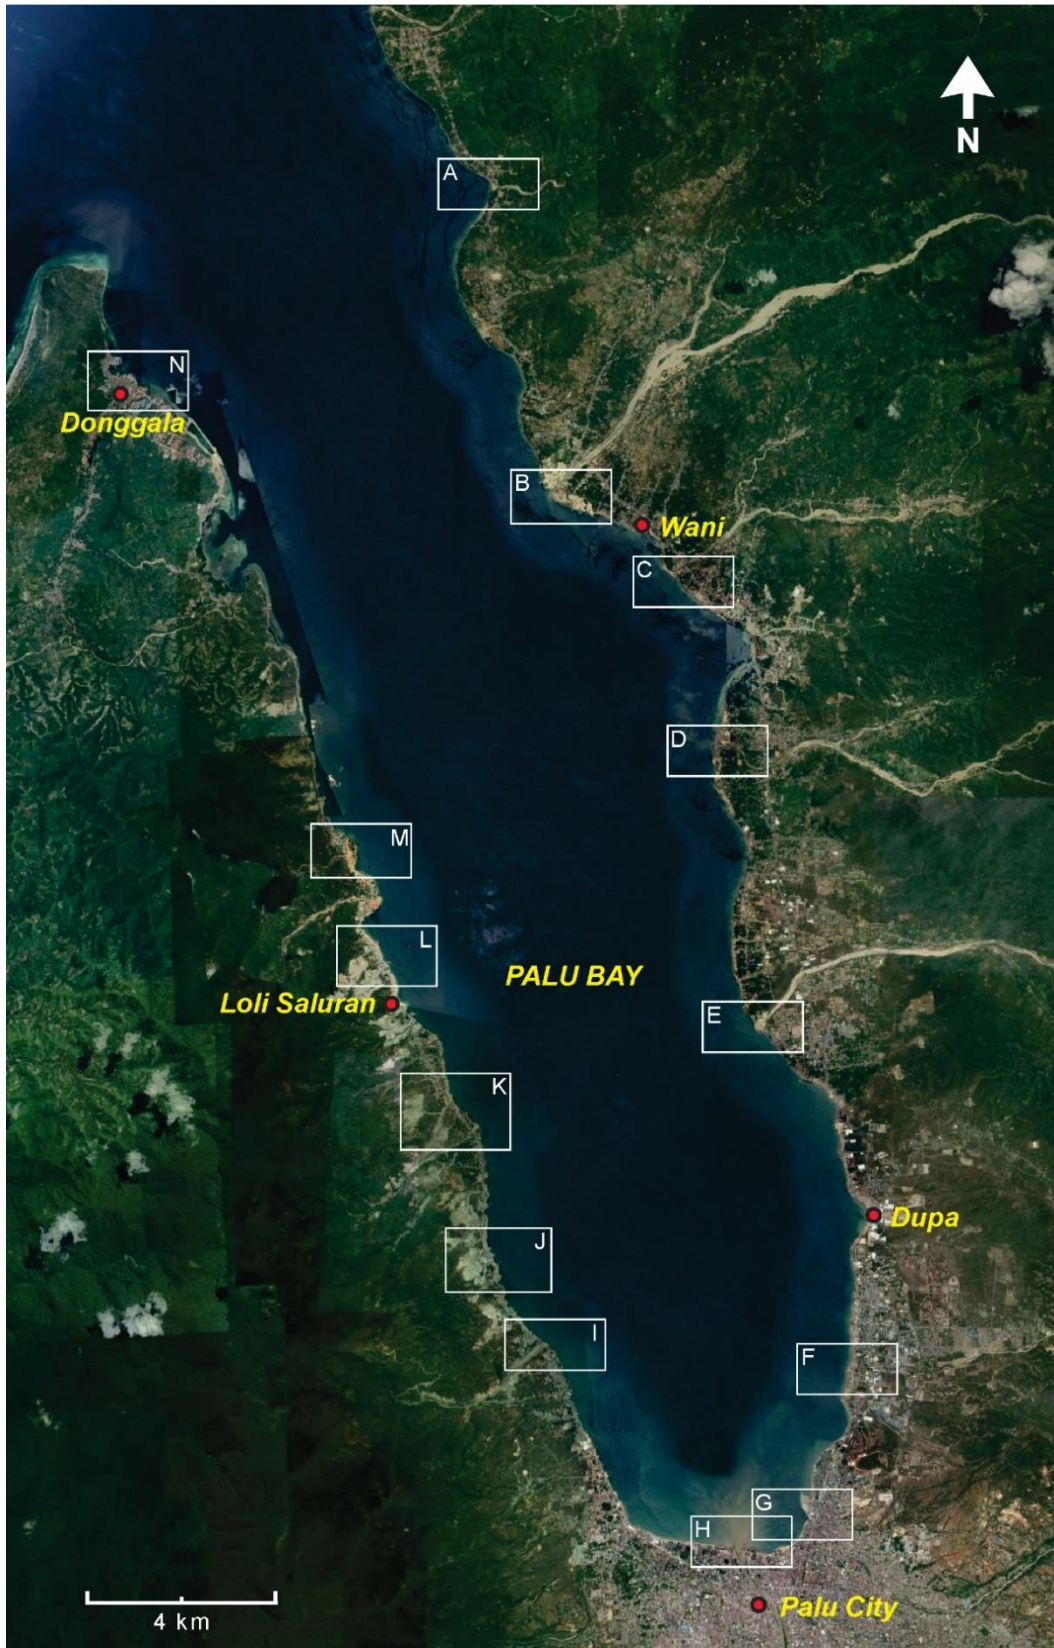
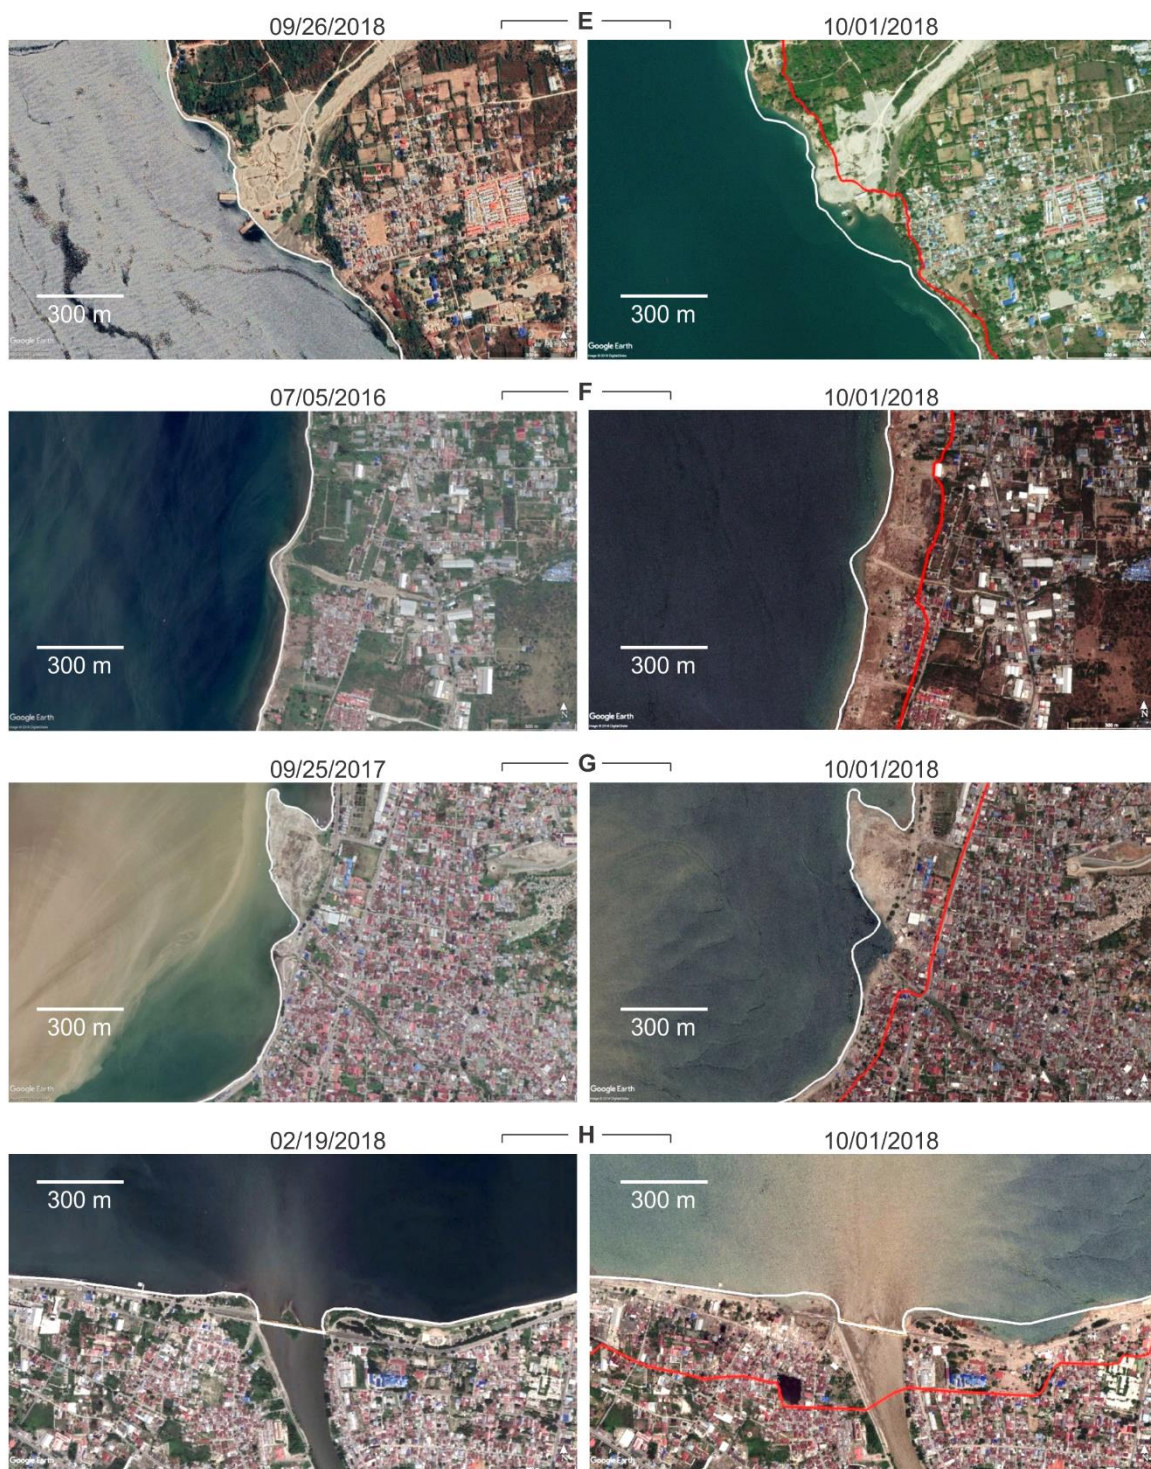
Figure S8

**Figure S8 (cont.)** Coastline retreat observations derived from the satellite image analysis. The first figure shows the index maps for areas in Palu Bay where coastal retreats were observed. The date of each pre-and post-earthquake photo is indicated above it. White lines indicate the pre-tsunami shoreline and the red line is the inferred inundation limit (see Fig. S5)
